An offsite mock-up was constructed to test the tools and technology that will be used to stabilize three underground structures near the Plutonium Finishing Plant.

*The U.S. Department of Energy is preparing to fill three underground liquid waste disposal structures with engineered grout to prevent their collapse and the potential to spread contamination. The grout will provide near-term protection of human health and the environment while not precluding future remedial or closure actions.*

# Aging Structure Stabilization (continued)

Updated 01/15/2020

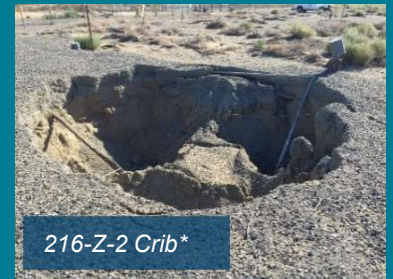
216-Z-2 Crib\*

*\*This photo shows subsidence, which was later filled, above a structure similar to 216-Z-2.*

## 216-Z-2 Crib

**Operations:** 1949 to 1969

**Size:** Excavated to 14 feet square and 21 feet deep; a 12-foot-square, 14-foot-deep open-bottom wooden box was installed within the excavation for support

**Waste Disposed of:** Together with 16-Z-1, the cribs received about 10 million gallons of waste, mostly from the Plutonium Finishing Plant

**Contamination:** Estimated discharge to cribs includes 6.8 kg of plutonium

**Estimated Grout Volume to Stabilize:** Not Applicable

**Completion:** Additional assessments on the Z-2 crib demonstrate that the existing soil cover provides proper protection.
